Manhole Inspection Summary

Manhole # S25Q__002MH

Insp Date: **4/9/08 11:11 AM**

Location Address: **1327 BAYARD ST.**

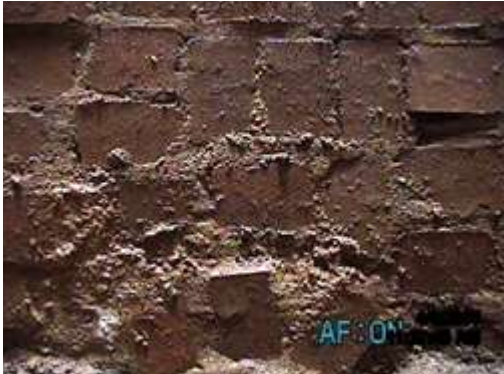
Defect 1

Infiltration: ☐ None ☐ Joint ☐ Cracks ☒ **Mortar** ☐ Roots ☐ Wall

ACTIVE BARREL INFILTRATION AT
MORTAR

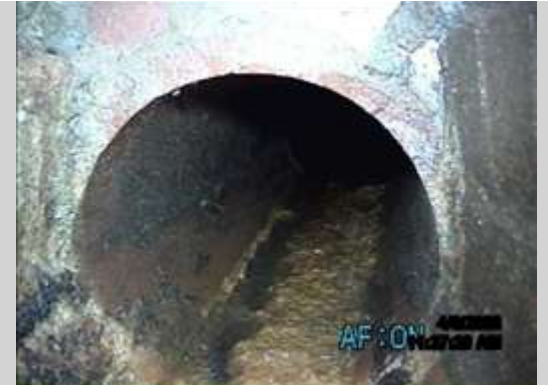
12 O'Clock Outflow

10 in. Circular Gravity Sewer
Pipe Out @ 12 O'Clock

Pipe Height: **10.8** (in.) Rod and Bar (Angled)
Pipe Material: **Clay** ☐ Pipe Lined
Invert Depth: **13.30** (ft.) Flow Characteristics: **None**
Deposits: ☒ None ☐ **Mud** ☐ Sludge ☐ Debris ☐ Grease
Silt Depth: **0** (in.) Deposits Extent:
Infiltration: **None** Pipe Seal Cond: **Sound**

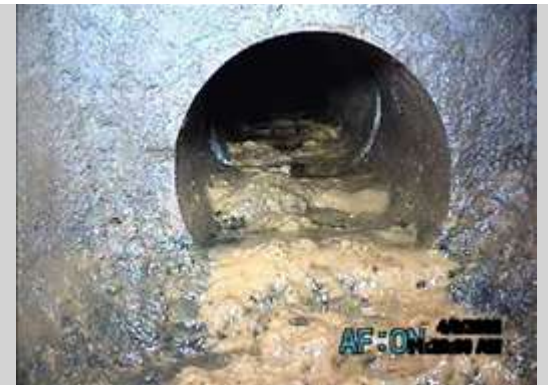
6 O'Clock Inflow

8 in. Circular Gravity Sewer
Pipe In @ 6 O'Clock

Pipe Height: **8.4** (in.) Rod and Bar (Angled)
Pipe Material: **Clay** ☐ Pipe Lined
Invert Depth: **12.60** (ft.) Flow Characteristics: **None**
Deposits: ☐ None ☒ **Mud** ☐ Sludge ☐ Debris ☐ Grease
Silt Depth: **2** (in.) Deposits Extent: **Light**
Infiltration: **None** Pipe Seal Cond: **Sound**
